Transit Speed & Reliability

Spot Improvement Bi-Annual Report

December 2005

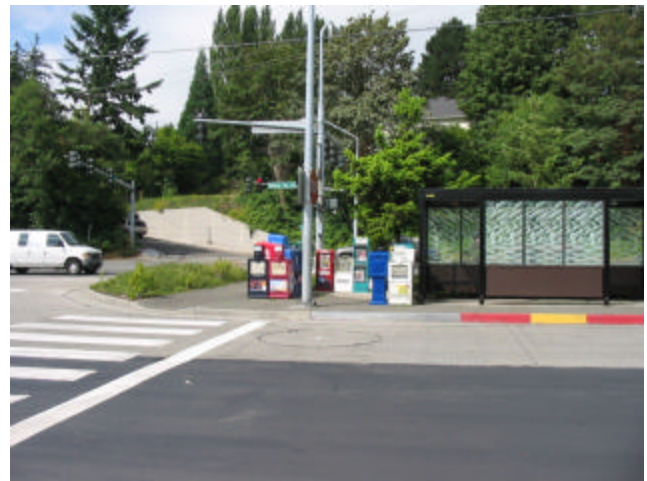
South Bellevue Park & Ride

Transit coaches experienced high levels of delay while accessing the S Bellevue P&R. Delays were due to heavy traffic flow on Bellevue Way SE, and long red lights at the 112th Avenue SE signal located at the P&R exit.

Because Bellevue Way SE serves a heavy amount of traffic coming to and from I-90, it was not possible to adjust the normal signal timing to reduce delay to vehicles entering/exiting the P&R without adversely affecting traffic on Bellevue Way. A Transit Signal Priority system was proposed as a solution to reduce delay to buses accessing the P&R.

In a partnership with Sound Transit and City of Bellevue, TS&R designed a Transit Signal Priority system that uses specially placed loop detectors for bus detection. Blue indicator lights were installed to notify transit operators when their bus is detected. When the signal priority system is activated signal timing is modified to reduce transit delay.

Delay has been significantly reduced to southbound coaches that operate through the P&R. TS&R staff evaluated transit delays before and after the signal priority system was operational, and recorded an average savings of over one minute to SB coaches during the AM peak.

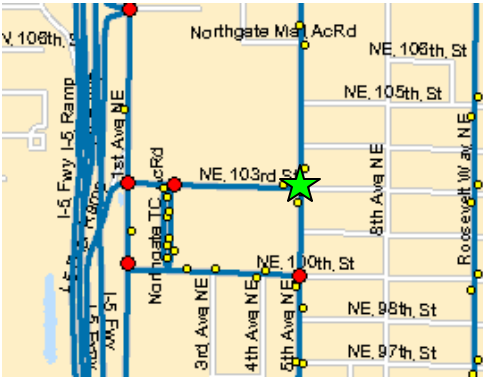
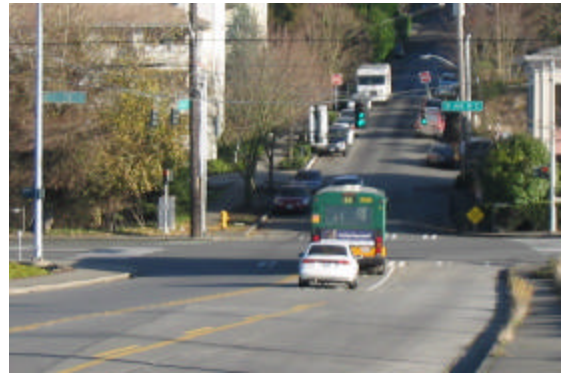
5th Avenue NE & NE 103rd Street NE

During a recent North Base visit by a Speed & Reliability engineer, Route 41 operators complained about a long delay while turning left from NE 103rd Street to 5th Avenue E.

TS&R staff visited the location and confirmed that eastbound traffic had a long delay at this signal. Staff also observed that there was light traffic traveling on 5th Ave NE, and that the signal operated in coordination for north-south traffic only.

TS&R staff reported the findings to a SDOT technician. Coordination was turned off for north-south traffic, which allows the signal more flexibility to adjust the timing based on traffic detected on other approaches.

The signal is now more responsive to traffic traveling eastbound on NE 103rd St. This reduces delay to the outbound Route 41 and other transit routes.

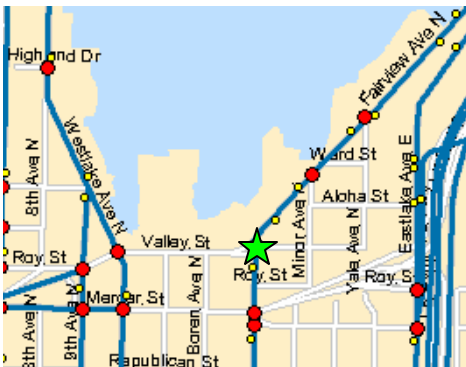
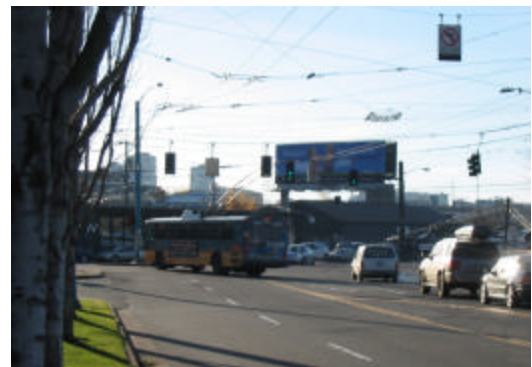
Fairview Avenue N & Valley Street

Route 70 operators reported that the left-turn arrow at the intersection of Fairview Avenue and Valley Street was not operating correctly.

TS&R visited the location and observed that the left-turn signal was timed to provide a protected left-turn arrow after a permissive left-turn phase. Staff observed that the signal would work better for buses if the arrow was displayed prior to the permissive phase.

SDOT signal operations engineers had recently re-timed the signals in the area, and had made an adjustment to the phase order of the left turn arrow. Based on feedback received from TS&R, SDOT returned the signal to the original phase order.

Route 70 coaches can complete the turn during the protected left turn phase, or can turn during the permissive phase as gaps in oncoming traffic allow. Coordination between this signal and the next signal at Mercer Street is greatly improved.

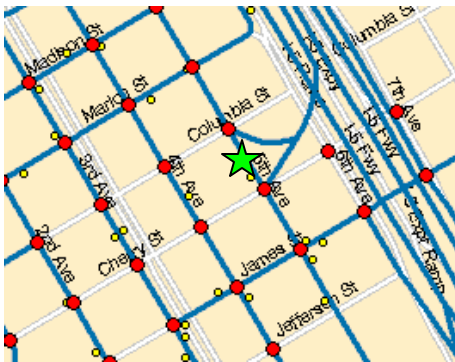
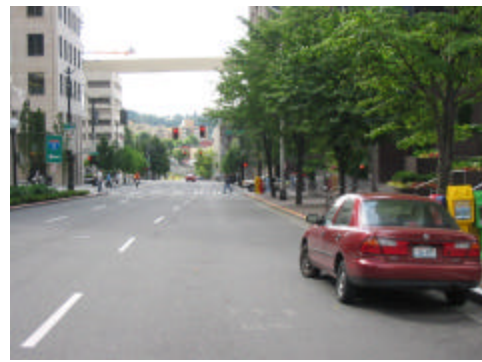
5th Avenue & Columbia Street

At a recent East Base visit, operators reported that vehicles were parking illegally just south of the load zone on 5th Avenue near Columbia Street, where the travel lanes make a shift to the right. These parked vehicles were encroaching into the travel lane, creating a safety hazard and impeding coach movement.

TS&R Staff visited the site and confirmed that a recurring problem existed at this location. Staff noted that the load zone (yellow curb) was directly adjacent to a bus zone (red/yellow curb), and that the curb use designation was unclear to drivers.

TS&R Staff contacted SDOT about the problem and suggested several ways to help prevent vehicles from parking in the troublesome spot. A 'NO STOPS' zone was installed between the loading zone and the bus zone, along with additional signs and red curb paint.

The new curb use designations make it clear to drivers that parking is not permitted in this location. Metro and SDOT staff will continue to monitor the site to see if additional markings or enforcement efforts are warranted.

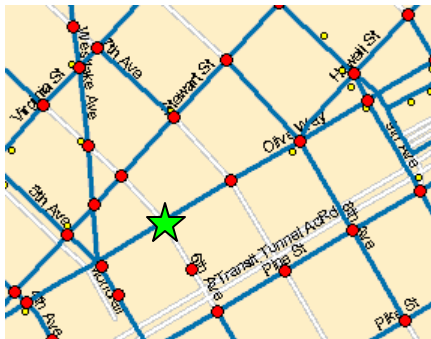
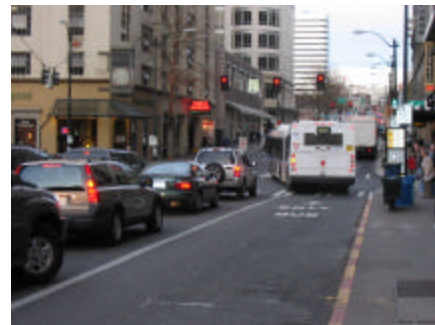
Olive Way & 6th Avenue

After serving the busy bus stop nearside of 6th Ave on Olive Way, outbound Metro KC and Community Transit coaches were experiencing difficulty merging over 2 lanes of heavy traffic on Olive Way to get to Howell Street 2 blocks downstream.

As part of the Olive Way Transit Priority improvements associated with the Downtown Transit Tunnel closure, King County and Seattle DOT visited the location to assess the feasibility of a queue jump and observe if signal timing could be allocated for transit priority. It was determined that a signal queue jump could be installed easily, at low cost, and without significant impact to traffic.

Vehicle detectors and a signal display were installed and signal timing was adjusted by SDOT crews to provide transit vehicles with an early green queue jump during the PM period.

The fix provides transit vehicles the opportunity to get an early green and conveniently merge over the 2 lanes of traffic without difficulty. Delays for other traffic movements are not adversely impacted.

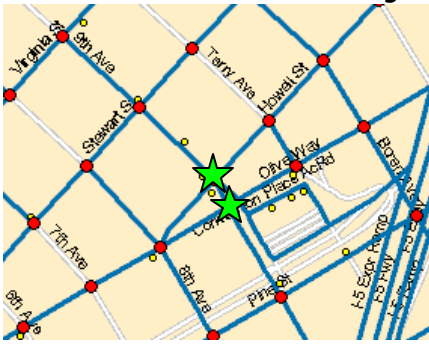
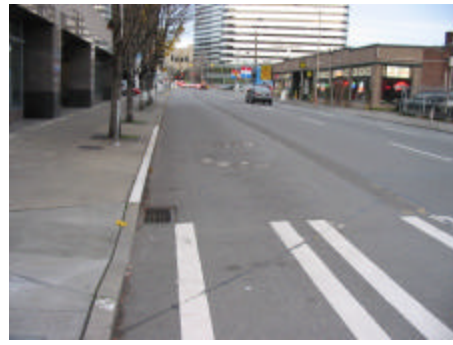
Olive Way / Howell Street / 9th Avenue

With the upcoming tunnel closure, high bus volumes were anticipated exiting and entering Convention Place Station (CPS) via 9th Ave. These increased volumes could potentially cause significant queuing and transit delay.

Metro KC and Seattle DOT staff met together in the field to evaluate ways to reduce the queuing and delay for transit at this key intersection. It was identified that converting Howell Street to one-way operation could reduce overall delays by eliminating a phase from the signal cycle. Also, it was determined that the original transit queue jump signal for northeast-bound buses, which had been removed earlier, could be re-installed.

The Howell contra-flow lane between 8th and 9th Aves was removed and replaced with on-street parking. The signal phase for this movement was eliminated. A signal display for the early green queue jump for transit was re-installed. Signal timing was reassigned so that transit vehicles entering and exiting CPS would receive more green time.

The new traffic and timing changes improve transit mobility through the intersection and can more easily accommodate the new transit volumes rerouted from the tunnel closure.

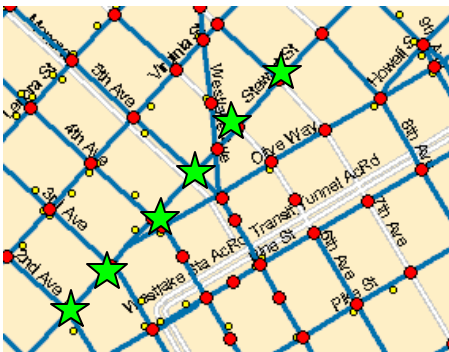
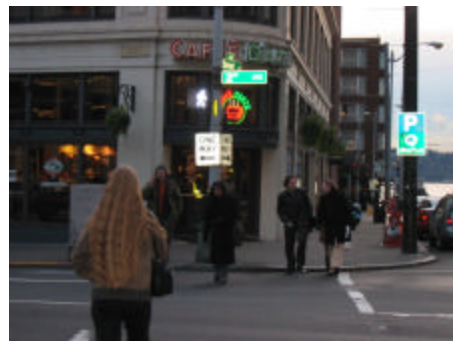
Stewart Street Corridor

With tunnel closure and increased traffic volumes on the Stewart Street corridor, long delays and congestion were reported by transit operators and customers. Transit vehicles were experiencing increased travel times of up to 30 minutes or more.

Metro and SDOT staff observed transit and traffic operations along the corridor, and attributed the delays to high transit volumes, on-street parking, congested bus zones, and traffic signal delays. Some quick-fix items were identified to provide immediate relief.

The quick-fix items that have been implemented include:

- * Restricting peak period parking at 12 stalls.
- * Moving some transit routes off of Stewart Street.
- * New pedestrian displays at Stewart & 2nd Ave
- * New skip-stop patterns for routes on Stewart Street.

These fixes are currently being evaluated and assessed for effective transit travel time and congestion reduction. Metro and SDOT staff are continuing to monitor transit operations in the corridor. Other near-term improvements being considered are additional on-street parking restrictions, bus zone closure, and re-timing of traffic signals.
