Transit Speed & Reliability

Spot Improvement Bi-Annual Report

December 2006

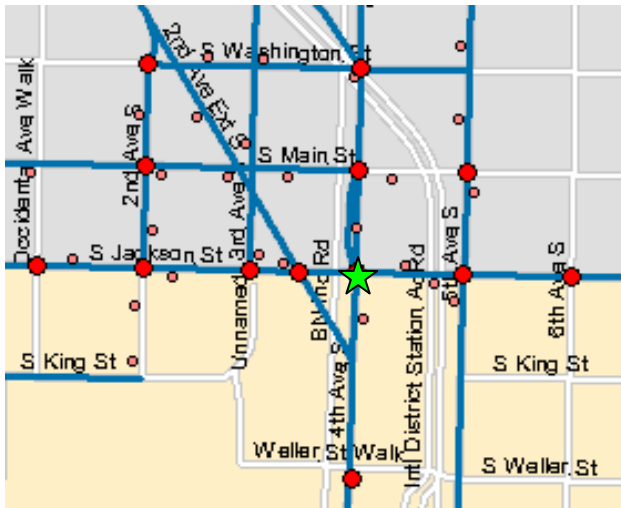
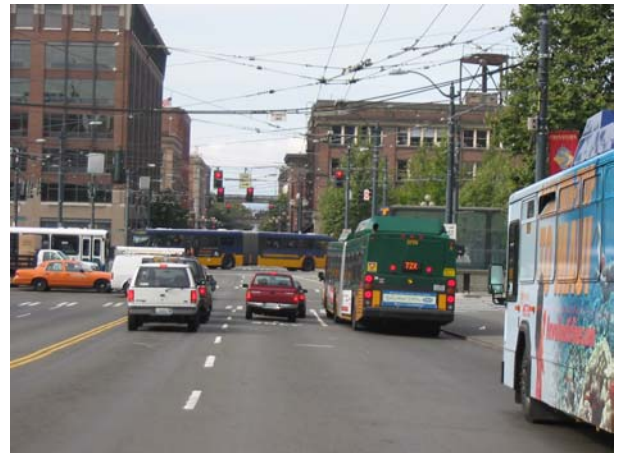
4th Avenue & S Jackson Street

Many transit coaches make a westbound right-turn at this intersection, and there is a busy bus stop near-side of the intersection. Transit operators complained that other drivers were making an improper turn from the adjacent through-only lane, and cutting them off.

S&R staff closely observed traffic operations at this location during peak and off-peak conditions. Staff concluded that the right-turn-only lane was adequately signed and marked, but that the markings were often obstructed by buses. S&R staff sent a request to the Seattle Department of Transportation (SDOT) to install additional markings in the through-only lane.

SDOT installed additional lane markings in the through-only lane, consisting of an arrow and "ONLY" symbols placed on the pavement. The new markings clearly communicate the proper and legal usage of this lane.

Vehicles making a westbound right-turn at this intersection now have a clear indication that they need to be in the curb lane to make this movement. The new markings should encourage vehicles to merge behind other vehicles, including buses that may already be waiting to make this turn.

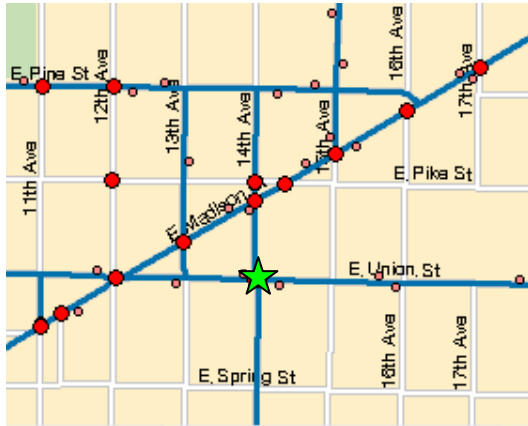
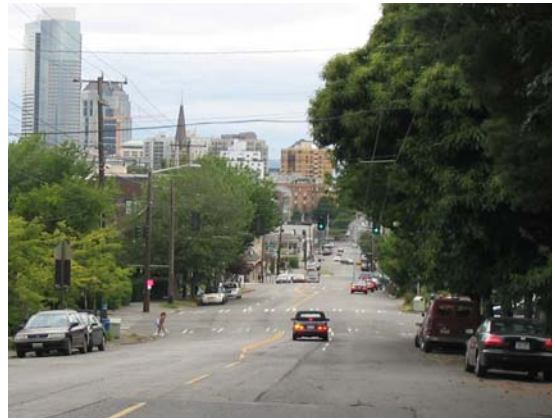
14th Avenue & E Union Street

Route 2 coaches traveling westbound through this intersection were having difficulty passing around a vehicle waiting to turn left, when the curb lane was occupied by parked cars. Operators requested parking restrictions near the intersection.

S&R staff observed operations, took measurements at the intersection, and worked with SDOT to develop a solution. It was determined that two full-width travel lanes could be provided for westbound traffic by simply shifting the center line a few feet to the south. This would achieve the desired effect without the need to eliminate any on-street parking.

The centerline was shifted and additional lane striping was added to the eastbound and westbound approaches, to provide two full-width travel lanes on both intersection approaches.

Coaches are now able to easily move around other vehicles, if there are any waiting to turn left. In addition, buses can use the additional lane to bypass other queued vehicles and move easily into the far-side bus zone.

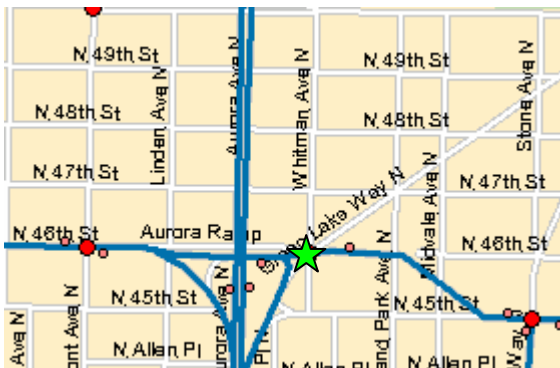
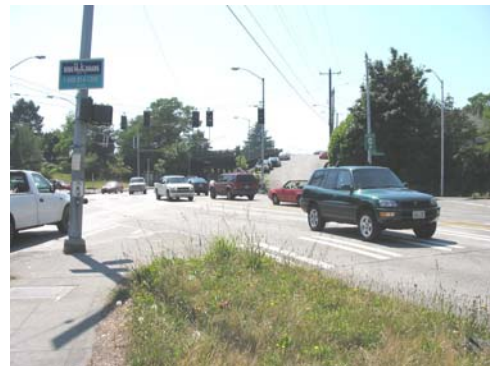
N 46th Street / Green Lake Way N / Aurora NB Off-ramp

Route 44 operators reported excessive delay while traveling eastbound and westbound through the intersection. Coaches would idle at the red light for long periods while little traffic was served in the opposing directions.

S&R Staff obtained signal timing information, traffic counts, and made several field visits. It was determined that the signal used the same timing plan throughout the day and was not effectively detecting traffic to adjust the timing.

SDOT installed a new video-detection system and revised the signal phase order. The video detection allows the traffic signal to adjust to changing traffic conditions.

The signal is now more responsive to the immediate traffic demands, which reduces delay to east-west traffic, particularly during mid-day periods.

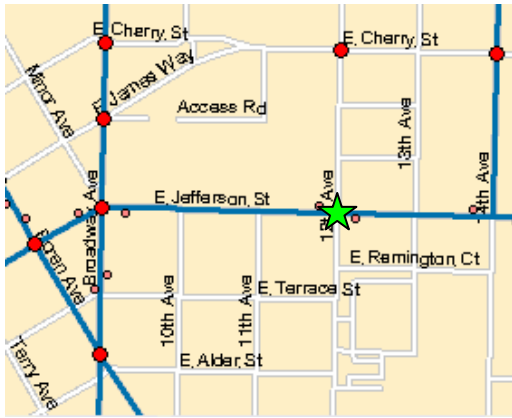
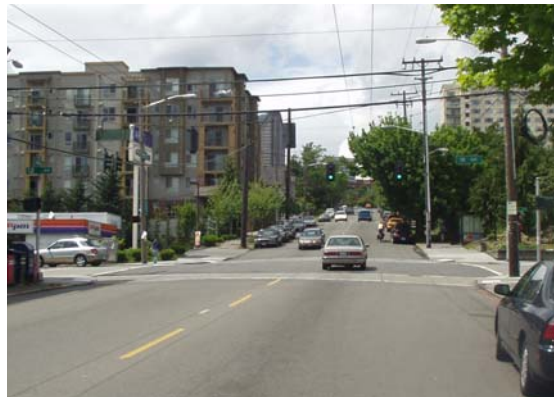
12th Avenue & E Jefferson Street

During a recent effort to improve on-time performance along important transit routes, this signal was flagged as a major source of delay to Metro routes 3 and 4.

Based on feedback received from the on-time performance evaluation, S&R staff investigated the signal timing at this location. After making field observations, collecting traffic data, and evaluating alternatives in a traffic model, it was found that some green time could be shifted to East-West traffic with few impacts to North-South traffic.

New signal timing plans were developed for the AM, mid-day, and PM periods. The proposed timing plans were reviewed, approved, and installed by SDOT staff.

The new timing provides an additional 8 to 18 seconds of green time for east-west traffic, which reduces delay to the bus routes 3 & 4, plus others.

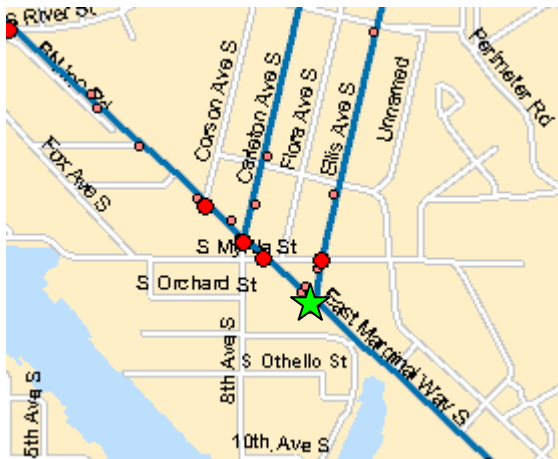
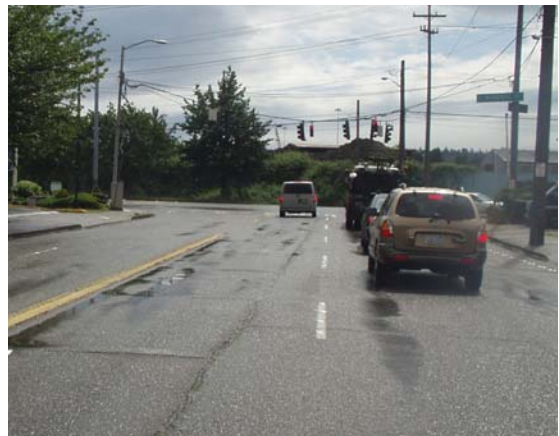
East Marginal Way S & S Ellis Ave

During a recent effort to improve on-time performance along important transit routes, this signal was flagged as a major source of delay to Metro routes 131/134 and 60.

S&R staff investigated the signal timing at this location, then evaluated and proposed several alternate signal timing strategies for SDOT's consideration.

The cycle lengths of this signal and other nearby signals were reduced by 10 seconds.

The reduction in cycle length effectively reduces the amount of time that traffic approaching on Ellis Ave. has to wait for a green signal.

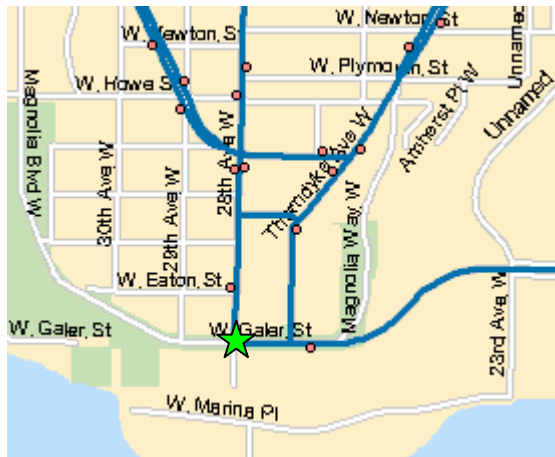
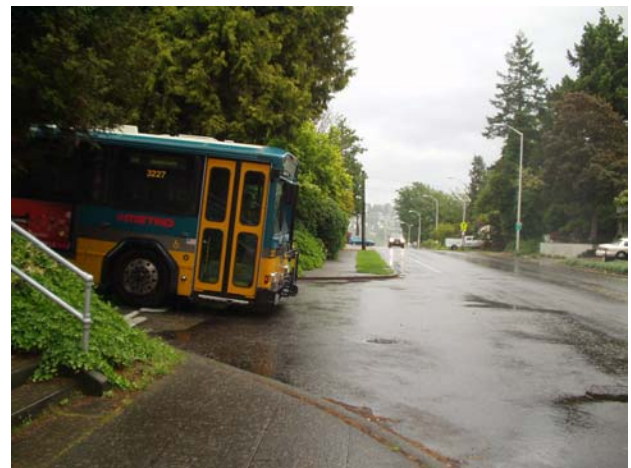
24th Avenue W & W Galer Street

Operators reported that it was difficult and time-consuming to turn left from this stop-controlled intersection. An all-way stop was requested.

S&R staff investigated the intersection and collected traffic counts. The traffic volumes did not meet national guidelines for installation of an all-way stop control. However, some overgrown foliage was discovered encroaching into the public right-of-way, which was obstructing sight lines.

Transit Route Facilities staff made a request to have the foliage trimmed by the property owner. The offending shrubbery was subsequently eliminated.

The improved sight lines make it easier for southbound traffic, including Metro routes 19, 24, and 33, to see when it is safe to proceed through the intersection.

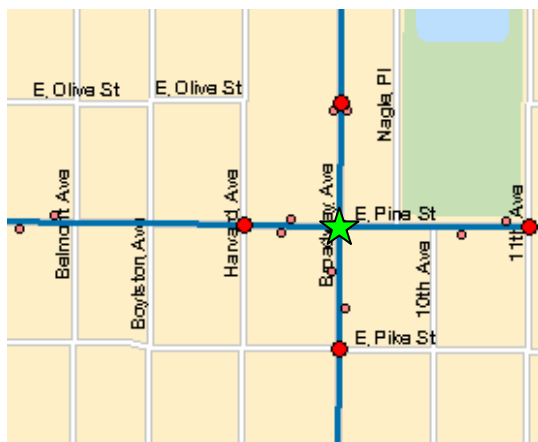
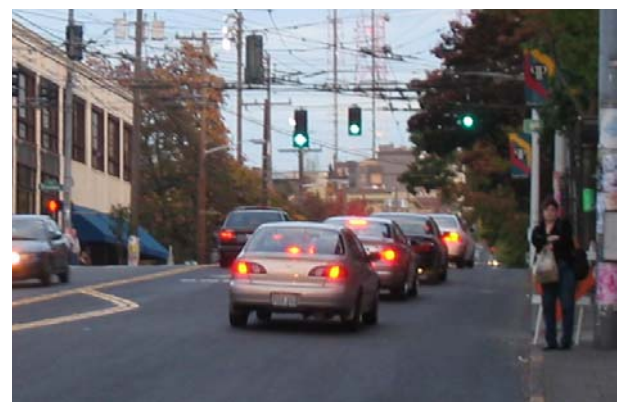
Broadway Avenue & E Pine Street

Route 49 coaches had a difficult time making the eastbound left-turn due to a heavy flow of oncoming traffic and pedestrians.

S&R staff collected traffic counts, transit coach delays, and submitted requests to SDOT to install left-turn phasing for buses making this movement.

New protective-permissive left turn signals were installed for the eastbound and westbound left turns.

Route 49 coaches can now complete the eastbound left turn more easily and with less delay.

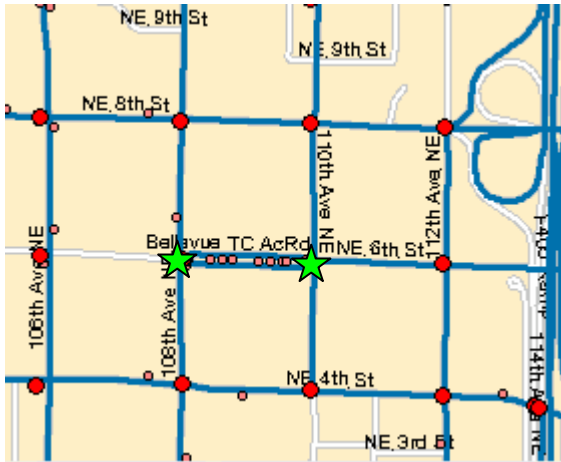
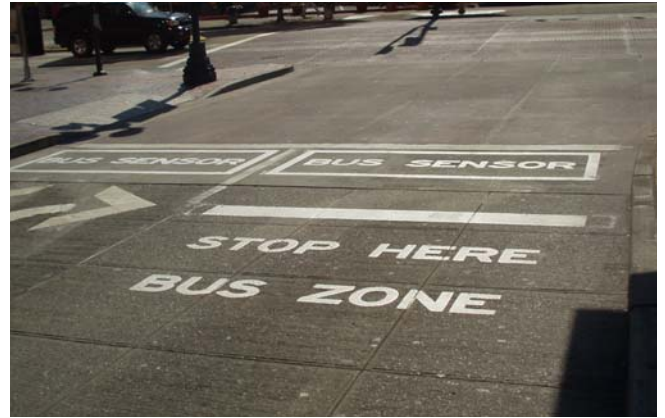
Bellevue Transit Center

City of Bellevue engineering staff contacted S&R about a problem with coaches parking on their traffic signal loop detectors at both ends of the BTC while loading passengers or while on layover. Parking on the loops caused the traffic signals to needlessly hold a green light for the Transit Center roadway, which caused delays to traffic approaching from other directions, including other buses. Also, some transit operators reported not knowing exactly where some of the loop detectors were located to activate the traffic signal for their direction.

S&R staff worked with the City of Bellevue and Metro Safety and Training Officers to develop a solution. Designations were needed to tell transit operators where to stop their coach while serving the bus zone, and where to stop in order to be detected by the traffic signal.

A distinctive pavement marking was installed at the front of the bus zones and over the loop detectors, to clearly communicate to operators the location of the loop detector. A special blue light illuminates when the detectors are triggered.

These measures have resulted in near-uniform compliance in keeping parked or loading coaches off of the loops, allowing the signal to operate efficiently. A similar treatment was installed at the South Bellevue Park & Ride, where loop detectors are used to activate transit signal priority timing.

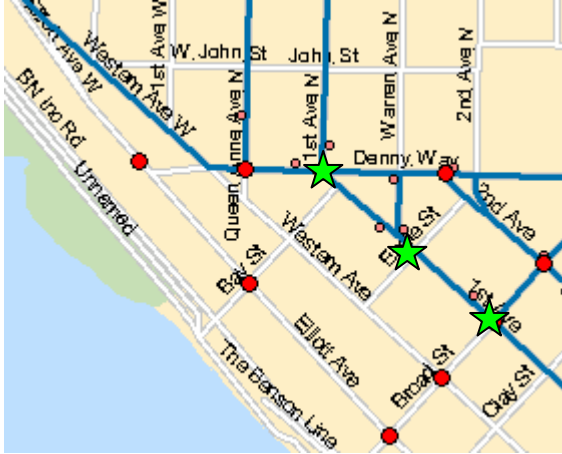
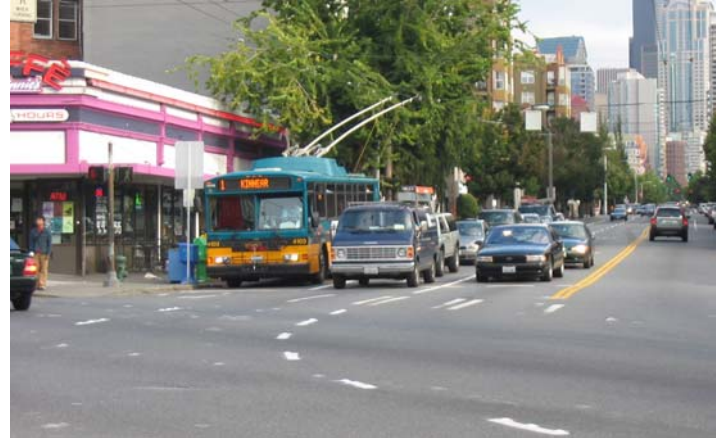
1st Avenue & Denny Way

Both transit and general purpose traffic were observed waiting for more than one signal cycle to clear this intersection during the PM peak hour. The traffic queue was observed to back up past the 1st Avenue & Broad Street intersection during the PM peak hour.

S&R staff worked with SDOT to develop solutions to improve general traffic flow, and also to allow buses to bypass the traffic queues.

On-street parking along the east curb was restricted and a PM peak period transit lane was installed between Broad Street and Denny Way. Previously, some signal timing adjustments were made to improve traffic flow northbound on 1st Avenue.

Routes 1, 2, 13, 15L and 18L coaches now have a dedicated lane to use on 1st Avenue approaching Denny Way, greatly improving travel time and schedule reliability.
