Transit Speed & Reliability

Spot Improvement Bi-Annual Report

Fall/Winter 2007

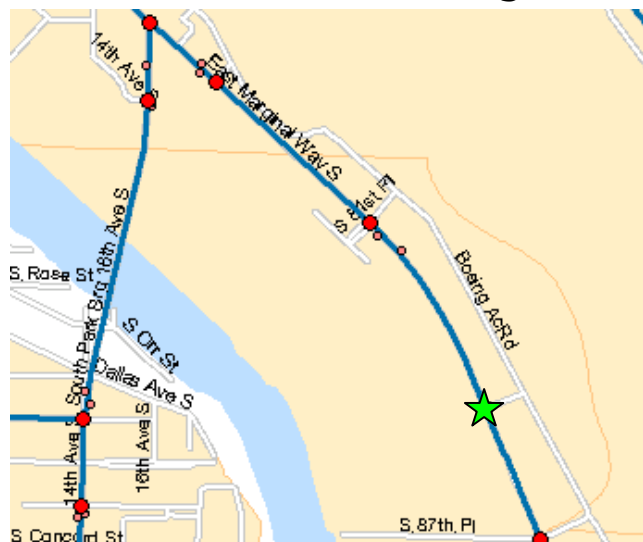
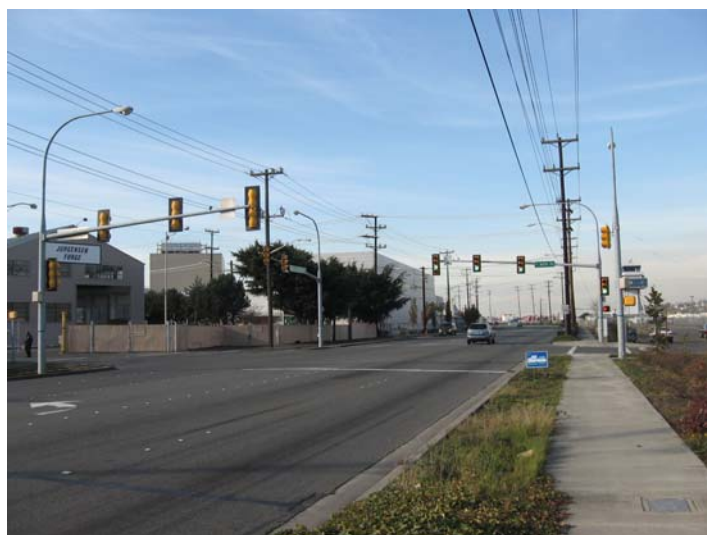
E Marginal Way S & S 86th Place

Through an OSFR (Green Sheet) a Route 174 operator from South Base reported that this signal was often red during late-night hours.

S&R staff visited the location during night-time hours and confirmed that the signal was stopping traffic on Marginal Way on every cycle. Since this signal has vehicle detection on the side street approaches, and there is very infrequent traffic on these approaches at night, the signal operation was determined to be abnormal. Upon further investigation, it was noted that a business located to the west of the intersection had installed a chain-link security gate directly over the loop detectors

S&R staff reported the findings to a signal engineer at the City of Tukwila. The signal engineer made some adjustments to the loop detectors so that they would not be tripped by the gate.

This quick fix returned the signal to proper operation, providing a continual green signal to Marginal Way unless vehicles or pedestrians are detected on the side-street approaches. This fix reduces delay to routes 154, 173, and 174 that operate through this intersection.

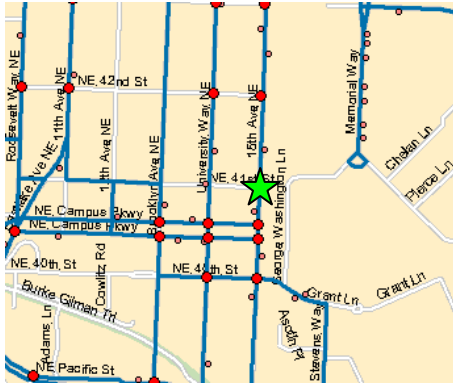
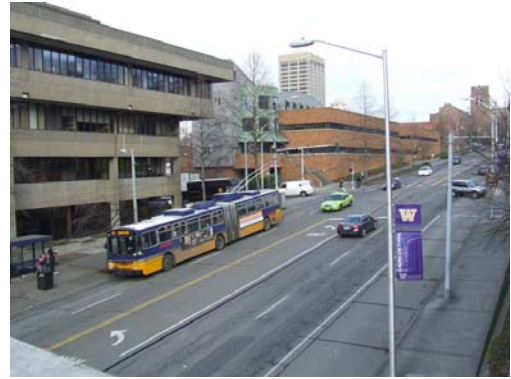
15th Avenue NE @ NE 41st Street

A transit operator reported that this signal was providing too much green time to the east-west direction while little traffic was being served.

S&R Staff visited the location and confirmed that the signal was not operating efficiently. A broken loop detector was the suspected cause. The findings were reported to a SDOT signal technician.

SDOT confirmed that a loop detector was not functioning properly. As an interim fix, the maximum green time for the east-west signal phase was reduced to provide more green time to north-south traffic.

The interim fix reduces delay for traffic and many buses on 15th Avenue NE. Eventually, the loop detector will be fixed so that the signal can respond to traffic.

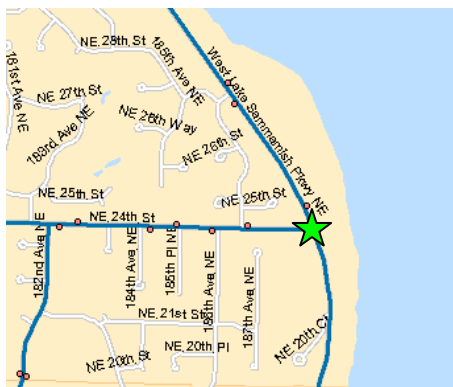
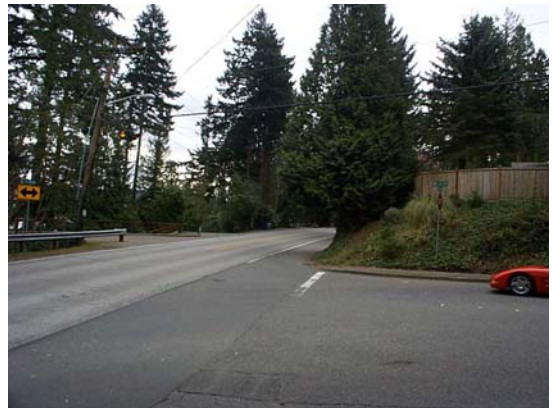
West Lake Sammamish Parkway & NE 24th Street

At a recent East Base visit, operators reported that the eastbound left-turn at this intersection was difficult. It was requested that an all-way stop be installed at this intersection.

S&R staff looked at traffic counts of the area and pulled up site photos taken at the intersection several years ago. Due to the high volume of traffic on West Lake Sammamish Pkwy, an all-way stop would not be warranted. However, the site photos suggested that sight distance could be improved by trimming some vegetation.

S&R staff contacted the City of Redmond and reported these findings. Redmond made an evaluation and trimmed some shrubs on the southwest corner to improve sight distance.

The trimmed vegetation helps vehicles on the eastbound approach see vehicles approaching from the south. This should help route 249 and 250 operators assess when the turn can be completed safely.

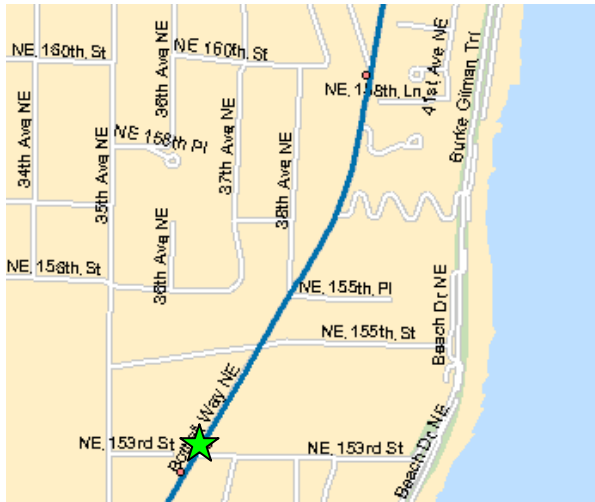
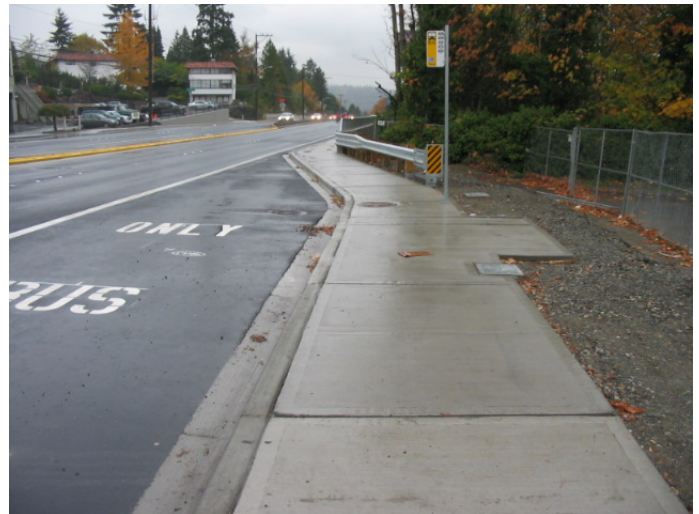
A new signal was being planned for the intersection of Bothell Way NE & NE 153rd Street in the City of Lake Forest Park. As part of this construction project, a new pullout was constructed for the Northbound bus stop. S&R and operations staff had concerns that buses would have difficulty pulling into traffic after serving the bus stop.

S&R staff worked with engineers at WSDOT to include a special bus loop at the head of the bus stop pullout area, as part of this capital improvement project led by WSDOT.

The bus loop is designed to activate a red signal on Bothell Way as a bus is ready to pull into traffic. The red signal creates a gap in traffic, providing an easy merge for the bus.

The bus loop at this new signalized intersection is an innovative solution to reduce delay to buses pulling out of a bus stop onto a busy state highway.
